Stormwater Retrofit of Existing Detention Basins

by Steve Trinkaus, PE, CPESC, CPSWQ & Sean Hayden, CPESC

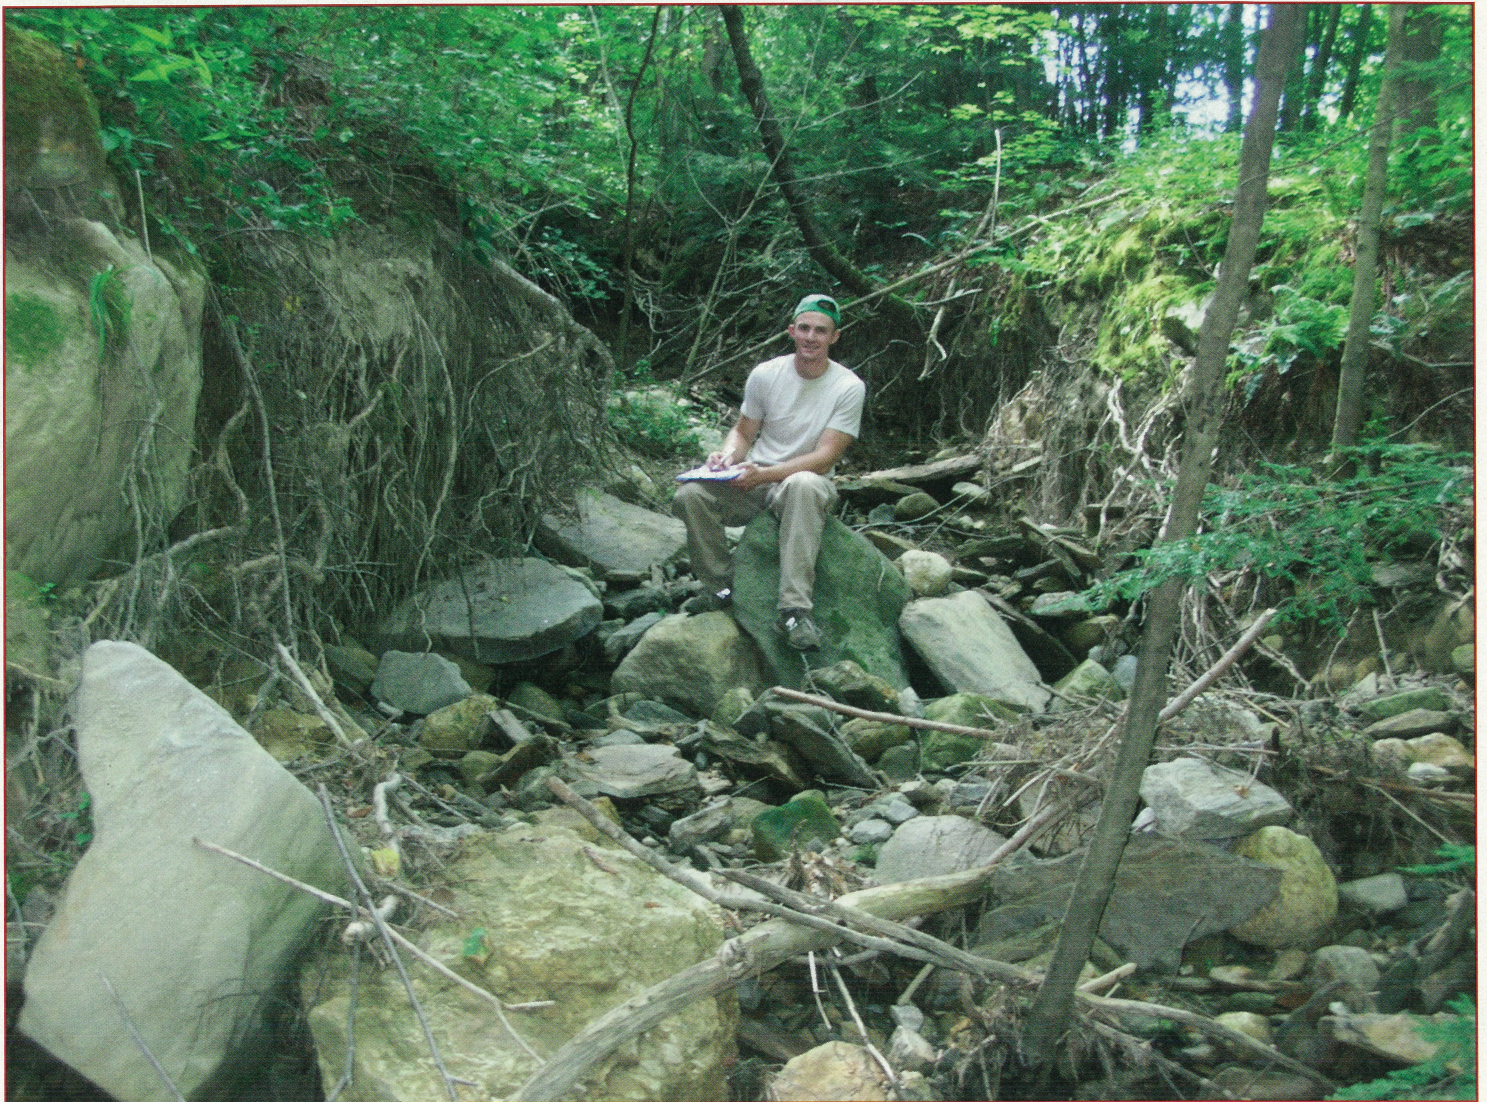
NCD employee. Shows erosion of the stream channel.

both basins not detaining any runoff and thus no reduction in the peak rate of runoff was provided. The increased runoff rates and volumetric increases had a detrimental effect on the receiving stream system. The existing stream experienced significant erosion, which contributed to the deposition of approximately 2,000 cubic yards of eroded material into Northfield Lake. Hayden's assessment was confirmed by Trinkaus Engineering during a subsequent inspection of the basins.

The outlet structure was modified to create a staged orifice system. Due to the size of this basin, the 2-year peak rate of runoff will be reduced from 30.66 cfs to 5.00 cfs. This is a substantial reduction that will prevent the further erosion of the existing stream channel between the basin and Northfield Brook Lake.

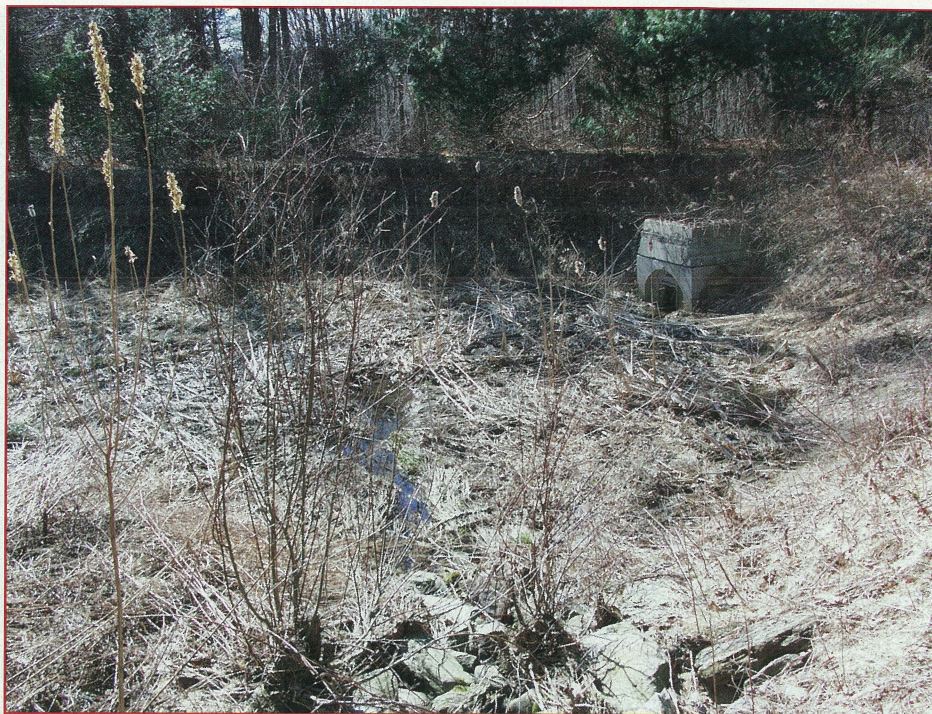
Inlet and outlet of small basin.

ture located at the northwest corner of the basin. Runoff is directed to the northeast corner of the basin by a riprap swale, which conveys the runoff from the road drainage system. Due to the proximity of the inlet and outlet, the flow of the runoff takes a direct path between the two points, rendering most of the basin useless.

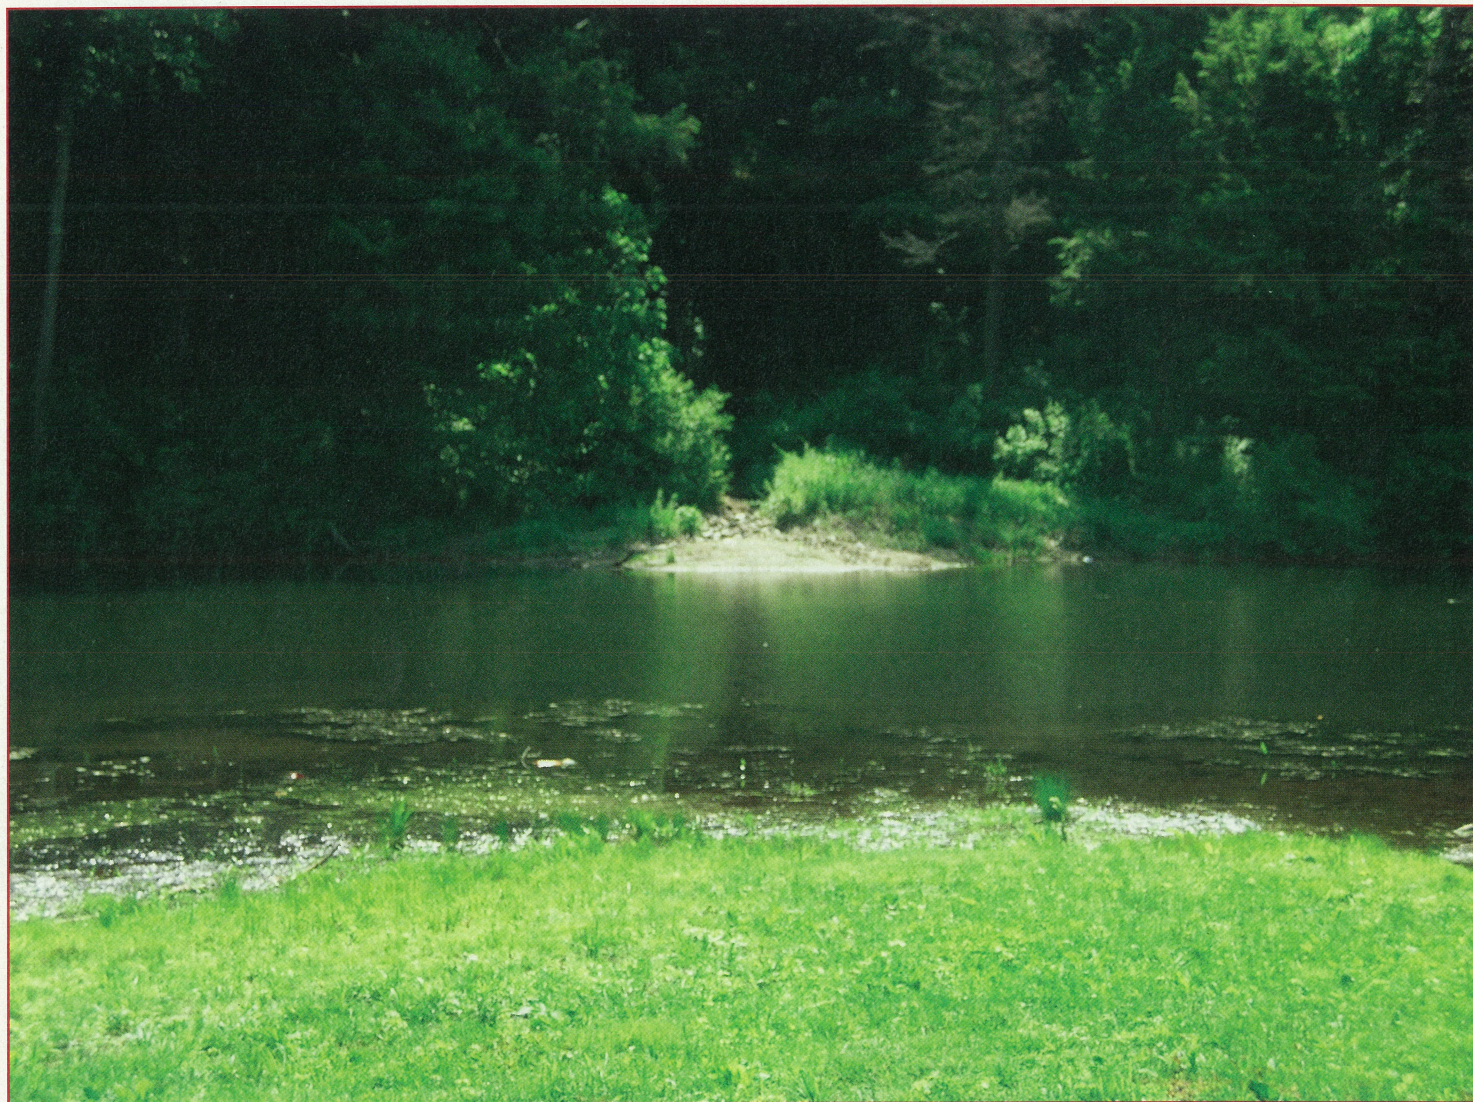
Sediment deposit in Northfield Lake.

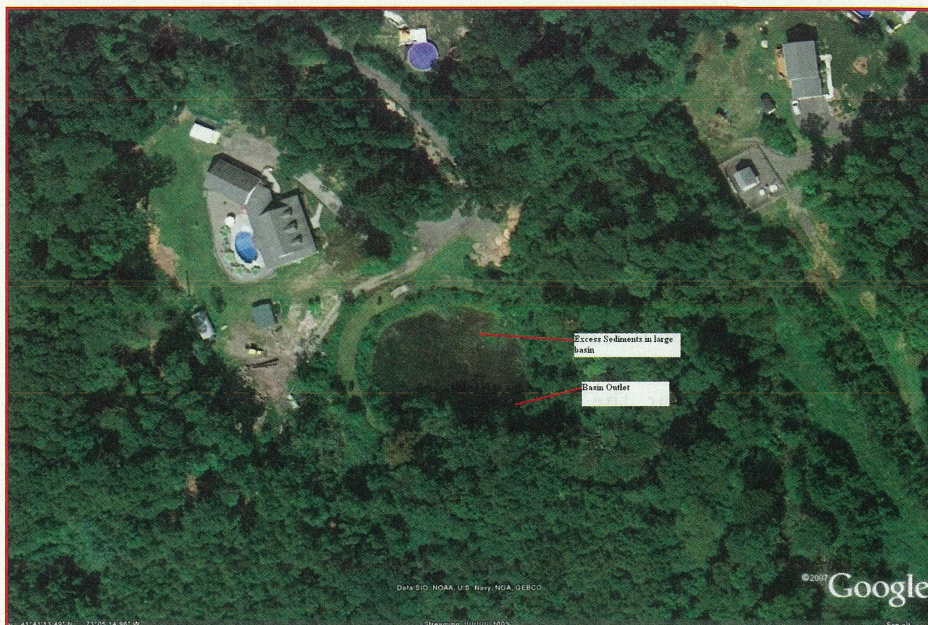
Aerial view of large detention basin.

The large basin has a 28.32-acre watershed area consisting of residential roads and half-acre single-family lots. The inlet swale enters this circular basin in the northeast corner while the outlet structure is located at the southeastern end. Similar to the small basin, short-circuiting of the basin occurs. The outlet control structure consists of a square 18" x 18" opening which does not provide any reduction in the peak rate of runoff. Approximately 8,500 cubic feet of storage is available below the invert of the outlet structure at the current time.
