Don't Lose Your LID

Learn These Lessons for Effective Stormwater Drainage

BY STEVEN D. TRINKAUS, PE

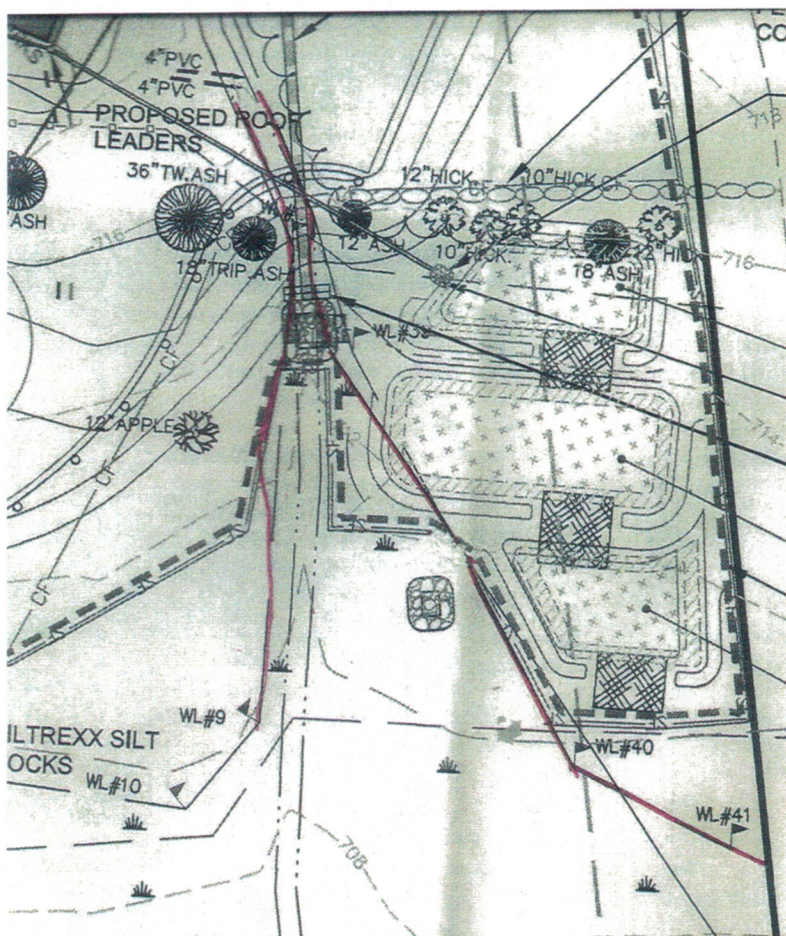
Figure 1. A rain garden located in and adjacent to wetland soil (red line) will never function properly.

The proposed rain gardens in Figure 1 are located partially in and adjacent to a delineated inland wetland soil, which is very poorly drained with saturation at or just below the ground surface. No soils tests of any type were conducted, so the designer would have no idea of the area's soil properties. In addition, these rain gardens were designed so the top of the soil media was located 1.5-2.0 inches below the ground surface, guaranteeing the rain gardens would be full of water at the start and never function at all.

If the designer had actually performed an appropriate soil investigation, it would have shown that both sites were not appropriate for installing rain gardens in the proposed locations. The designer would've been able to choose another type of LID system that would have been appropriate for the soil and hydrologic conditions.

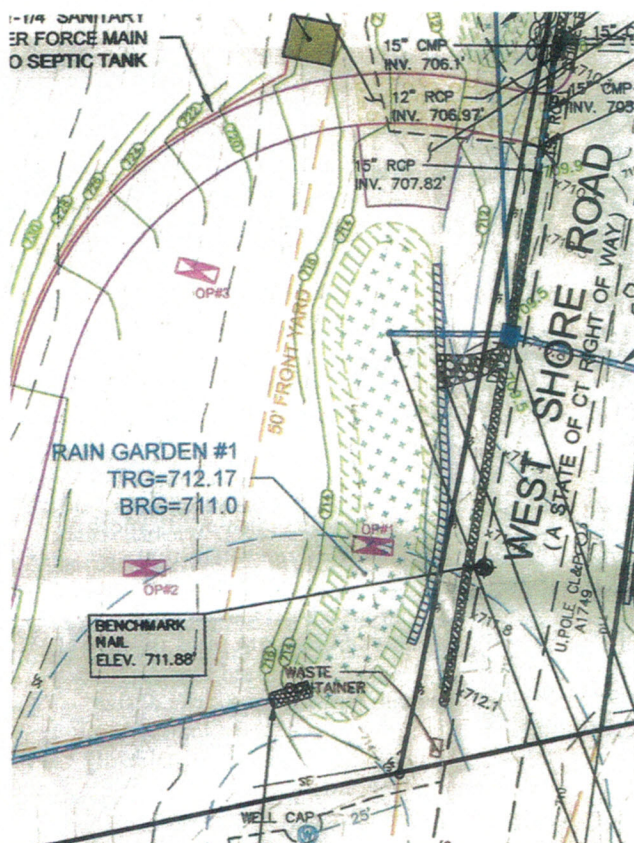
The proposed rain garden in Figure 2, although not near a poorly drained soil, has the top of its soil surface 2.5 feet

Figure 2. A rain garden on Class C soils also will fail prematurely.

below existing grade where there's a compacted impermeable layer and SHGW located 1.5 feet below the ground surface. This system will be inundated with groundwater and also will fail prematurely.

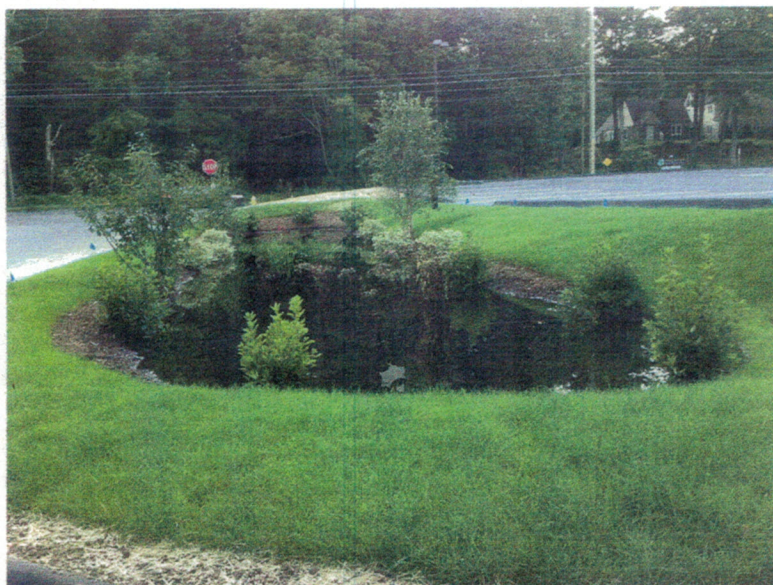
Figure 3. Another ineffective rain garden was installed above previously filled wetland soils.

Figure 3 shows a rain garden installed into fill material over an underlying wetland area. Over a period of a week with two rainfall events, the depth of the ponding exceeded 18 inches and killed the upland plants on the bottom of the rain garden. The owner subsequently attempted to correct this issue by installing a perforated underdrain through the center of the system. The underdrain was located directly below the ground surface along the center low point, so water doesn't pond, but the solution offers no treatment of the runoff from the adjacent commercial parking lot.

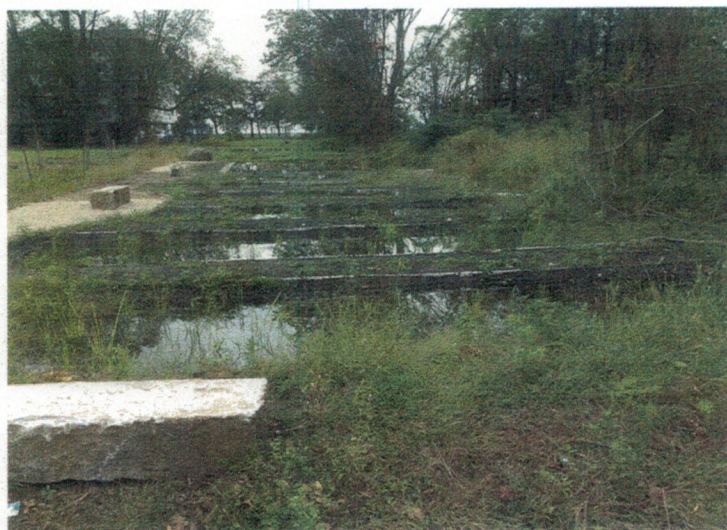
Figure 4 shows a series of bioretention systems installed as a demonstration project of how LID can work in an urban environment. Unfortunately, the top of the soil media was installed below the observed SHGW level, so all the systems immediately filled with water, and no infiltration or water quality improvement ever occurred.

In this case, a site investigation was done, and the civil engineer recommended raising the systems to provide a minimum 12-inch vertical separation from the bottom of the soil media to the SHGW level. Unfortunately, the principal in charge tried to address this issue by adding more

soil in each cell rather than taking the civil engineer's advice, resulting in a shallower visible ponding depth and more-saturated soil that has become host to native wetland plants.

Figure 4. A rain-garden demonstration project failed to follow engineering recommendations ... and failed.

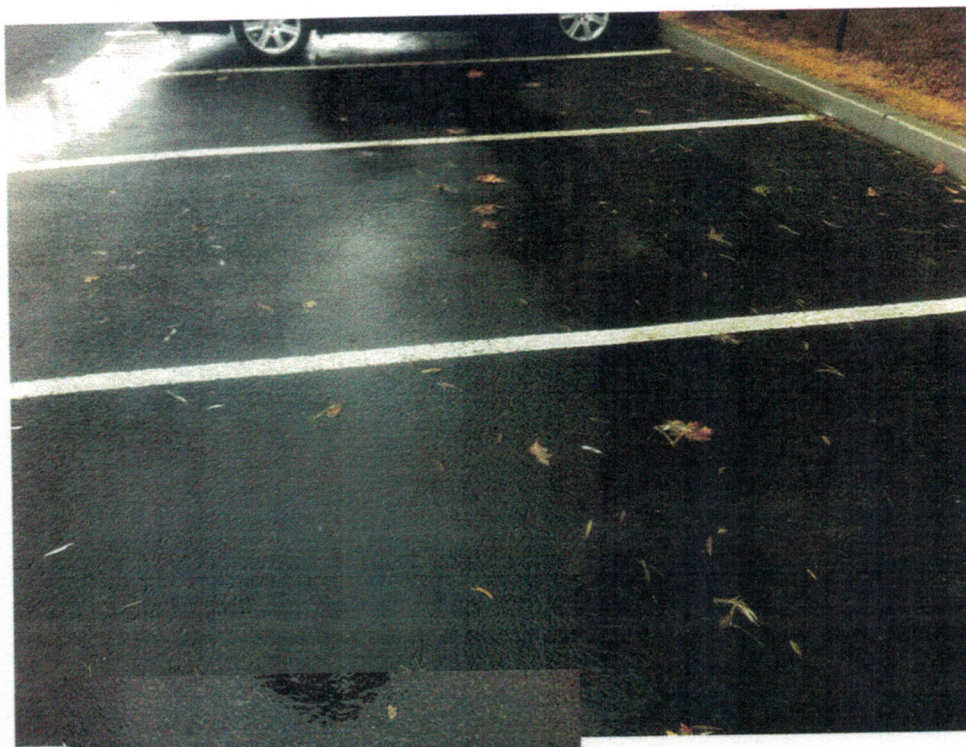
Bioretention systems aren't the only types that can fail from design, installation and maintenance issues. Figure 5 shows a permeable pavement installation built with no knowledge of the underlying soil conditions of a coastal environment in Connecticut. The permeable surface was installed on top of two layers of aggregate with an underdrain

Figure 5. A partially failed permeable-pavement system became clogged and simply discharged water at the bottom.

at the bottom of the aggregate. There's no water-quality improvement or volume reduction, as the rainfall is quickly directed to the underdrain and discharged to the coastal environment.

It also was installed early in the project's construction period, subjecting it to substantial construction traffic on a daily basis, with vehicles carrying soil on their tires that was deposited onto the permeable surface. In addition, no maintenance (e.g., frequent sweeping or vacuuming) was performed, so sediment built up and completely clogged the surface. These photographs were taken four years ago and, as of spring 2016, the clogging has substantially enlarged.

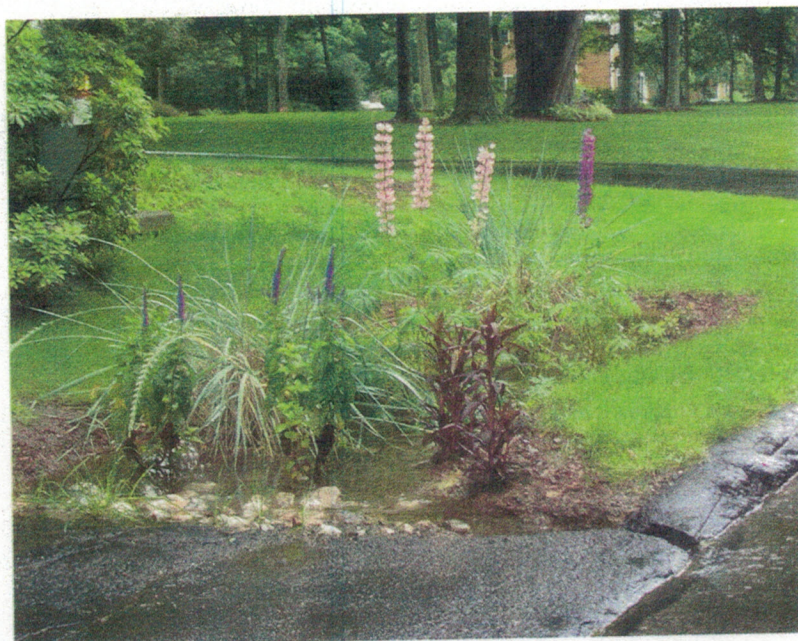
When a proper site investigation is performed, and the design is done by a professional with a thorough understanding of LID, the systems can function perfectly. Figure 6 shows a small bioretention system installed at the end of a residential driveway to treat and infiltrate runoff from approximately 2,800 square feet of road surface.

In this case, the homeowner dug a hole by hand to a depth of 36 inches and found well-drained sandy loam soils were present with no indications of SHGW. He proceeded to dig out the area, installed a soil media consisting of

medium-coarse sand and well-decomposed wood chip mulch and planted it with native perennials. The system has performed flawlessly for more than 10 years, with proper maintenance being performed in the spring and fall.

Figure 6. A homeowner built a successful bioretention system after properly analyzing the local soil.

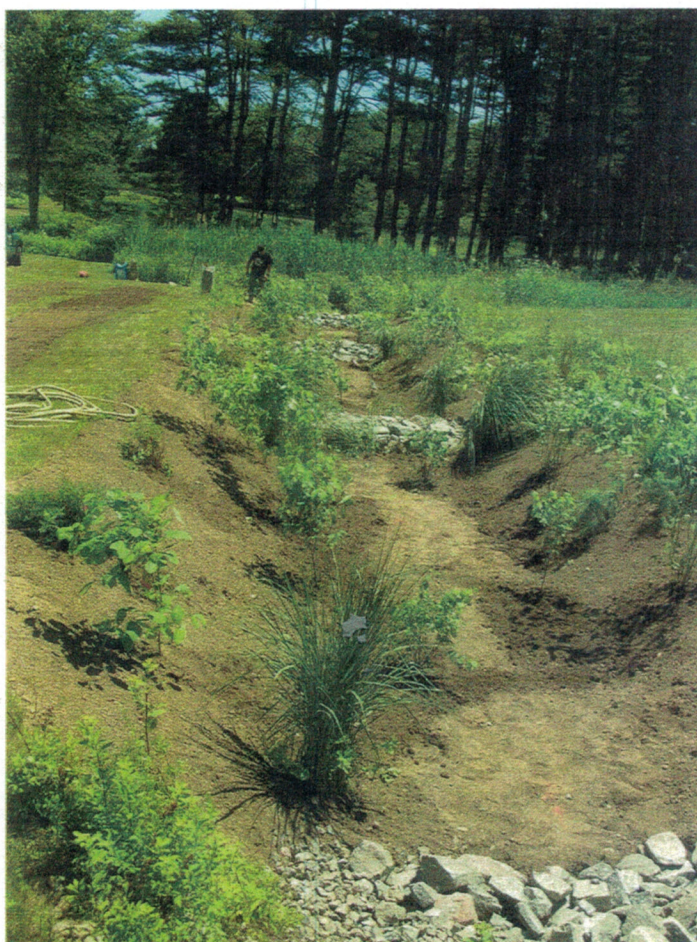
Figure 7 shows a bioswale (linear bioretention system), installed to replace a riprap swale at the outlet of a drainage pipe, a few days after installation.

Figure 7. A bioswale demonstration project replaced riprap swale at the outlet of a drainage pipe.

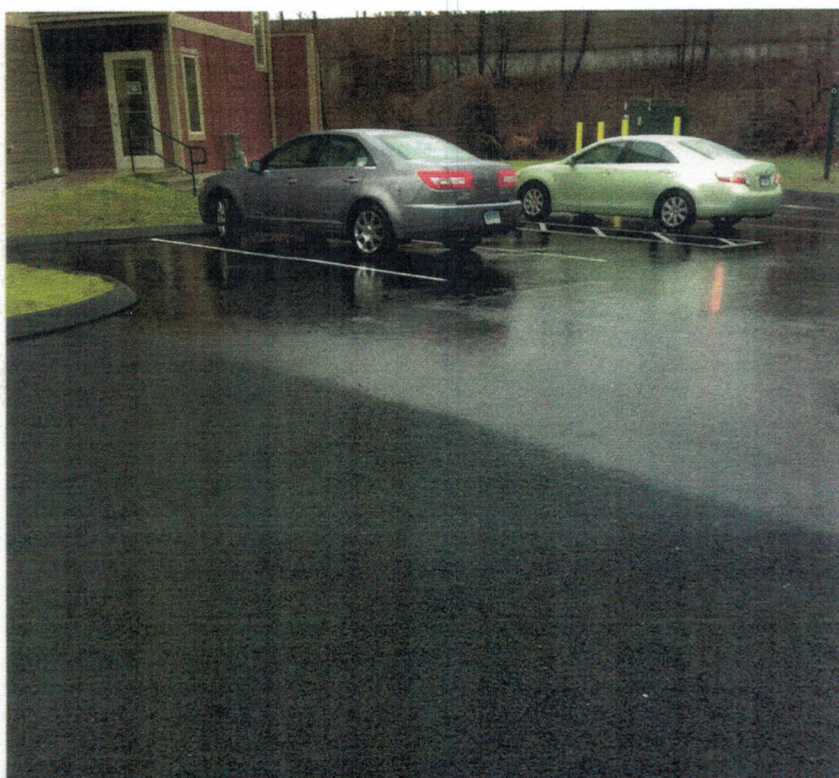
Permeable pavement is another LID infiltration system that can effectively reduce pollutant loads if installed with a filter course consisting of bank-run sand and gravel. For a project located along a tidal stream (see Figure 8), the design focused on pollutant load reduction, and any infiltration into old fill

material was considered a bonus.

Site investigation consisted of soil borings that found fill material approximately 30 feet in depth over original wetlands, as the site was filled back in the 1950s prior to Connecticut adopting inland wetland regulations. The permeable pavement was installed with a layer of sand and gravel on top of an aggregate layer, the latter to provide a fixed storage volume below the elevated underdrain to fully contain the required water-quality volume. The underdrain was located at the top of the aggregate layer to encourage infiltration into the fill material, which is occurring. Even when it had already rained 1.5 inches there was no discharge from the underdrain, which confirmed that infiltration was occurring into the fill material.

Figure 8 proves the effectiveness of permeable pavement (in the foreground), which shows no accumulated rainfall, while standard pavement (further back) shows plenty of accumulated rain.

Figure 8. During a rainfall event, permeable pavement (foreground) and standard pavement (further back) show very different levels of drainage.
